**Flood Control Project Maintenance
Levee Inspections**
LMA District Cover Sheet
Spring 2018 Levee Inspection Results

Sacramento River West Side Levee District

Spring 2018 Levee Inspection Results

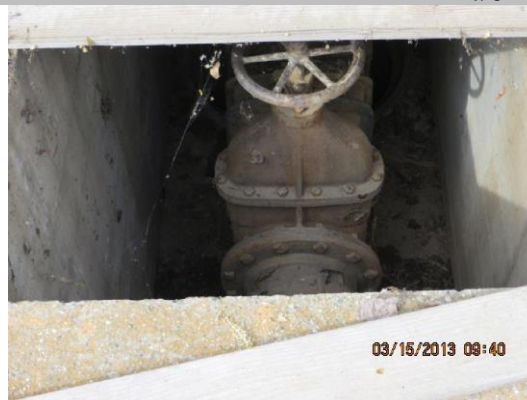
Photo 1 of 3 : UCIP_SP_2018_10306_17566.jpg

Comment Code					
Inspector Comment					
FS_ID:10306 DS_ID:20341 EP_NO: 9358 Repair Type: No Action Needed Crossing Status: Found UCIP Comments: FIELD_STRUCT_DESC: 16-inch steel drainage pipe through the levee, 8.5 feet below the crown. Siphon breaker inside a 24-inch corrugated metal riser unit on the waterside (WS) slope. Pump inside pump house on the landside (LS). Overhead power line crosses the levee. Pole on the LS shoulder. (one 12-inch, one 16-inch, and one 24-inch pipes [HLM 29.02] authorized under Automatic Board Order (ABO) issued as Permit No. 9358, 1974 - Crocker National Bank (Trustee)). [Additional Reference(s): DWR Levee Log, 2006. USACE Sacramento O&M Manual 131, May 1960 (HLM 29.02)]. FS Date: 3/15/2013

Gate valve under pumphouse on LS toe.

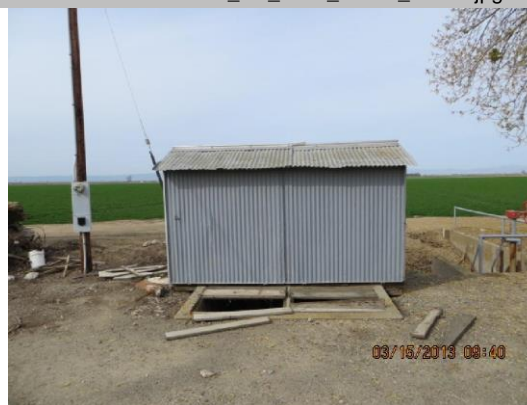
Photo 2 of 3 : UCIP_SP_2018_10306_17565.jpg

Pumphouse and sump on LS toe.

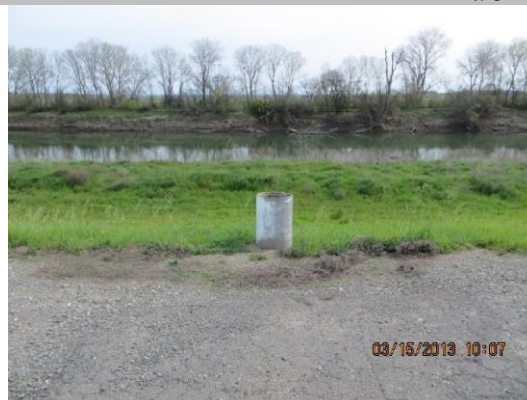
Photo 1 of 3 : UCIP_SP_2018_50042_17587.jpg

Comment Code					
Inspector Comment					
FS_ID:50042 DS_ID:20311 EP_NO: 12609 Repair Type: Urgent Crossing Status: Found UCIP Comments: 09/23/2016 - pipe outlet still submerged, but visible enough to determine that flap gate is still missing. Appurtenances on the LS of the levee do not appear to be associated with this pipe. There is no visible location for collection of drainage water to go through the outfall. As a result, it does not appear that this pipe is in use. (T. Hatch/UCIP) 09/01/201 - pipe outlet was submerged at time of inspection. Unable to view if flap gate had been replaced. Otherwise, conditions do not appear to be significantly different from previous inspection. (T. Hatch/UCIP) 03/15/201- Flap gate missing from waterward end of pipe. (W. Wylie/UCIP) FIELD_STRUCT_DESC: 24-inch steel outfall drainage pipe through the levee, 4.1 feet below the crown. Siphon breaker inside an 18-inch concrete riser unit on the waterside (WS) shoulder. Flap gate on the WS toe. Rock protection along the riverbank at the WS toe. (Permit No. 12609, 1978 - Jack E. Gross). [Additional Reference(s): DWR Levee Log, 2006]. FS Date: 9/23/2016

18-inch concrete riser on WS shoulder.

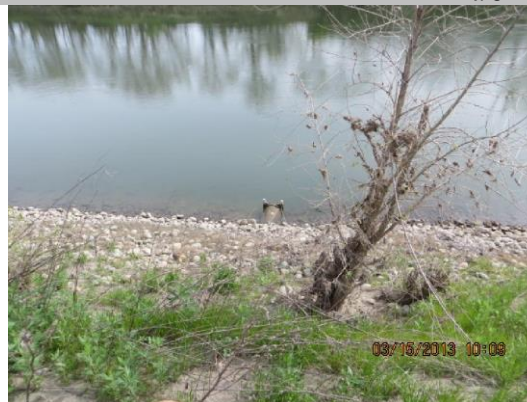
Photo 2 of 3 : UCIP_SP_2018_50042_17586.jpg

Pipe and flap gate at rivers edge

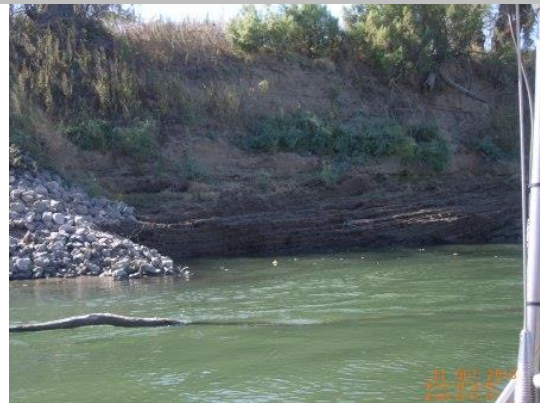
Photo 1 of 1 : SP_2018_NA0016_435_13_20180306_00012.jpg

LM Start	29.96	Rating **	M	Issue No.	13
LM End	30.00	Issue Type +	Ma	Location *	WS
Category	Supplemental			GPS Latitude/Longitude	
				Start	End
Item	2015 USACE Erosion Survey, DRAFT			39.065886 °	39.066287 °
				-121.842950 °	-121.843602 °
DWR ID	DWR_NA0016_01_s _ 2018_13				
Comment Code					
Inspector Comment					
2002 - Upstream end has recent slope failure and exposure of tree roots. 2003 - Some new minor slope erosion with new snags on the bank. 2004 - Appears a little worse. 2005 - Scallop in bank at the upstream end looks worse. 2009 - Minimal new erosion, Berm width is still large, but one large event or one fallen tree and it could go fast. 2010 - New erosion, bank is nearly all vertical from slumping. Site looks bad. 2011 - Site continues to look bad. 2012 - Minor new erosion. 2015: Undermining of toe rock. [2015 Site ID: SAC_122-3_R]

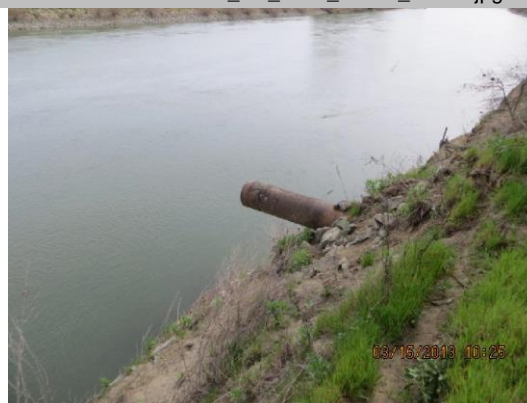
Photo 1 of 3 : UCIP_SP_2018_10325_17591.jpg

Comment Code					
Inspector Comment					
FS_ID:10325 DS_ID:20317 EP_NO: 14495 Repair Type: Non-Urgent Crossing Status: Found UCIP Comments: Pipe may need flap gate at water side. FIELD_STRUCT_DESC: 22-inch steel drainage pipe through the levee, 3.8 feet below the crown. Pipe extends from existing pump house located at the landside (LS) toe through the levee to the low-water channel. Siphon breaker in 24-inch corrugated metal riser unit on LS shoulder. (22-inch pipe authorized under Permit No. 14495, 1986 - Jack Gross; 22-inch pipe replaced previous 12-inch and 16-inch pipes, installed under Automatic Board Order (ABO) issued as Permit No. 9358, 1974 - Crocker National Bank (Trustee)). FS Date: 3/15/2013

24-inch pipe at rivers edge

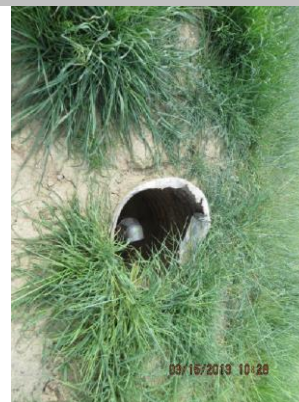
Photo 2 of 3 : UCIP_SP_2018_10325_17590.jpg

Siphon breaker in 24-inch cmp on LS shoulder.

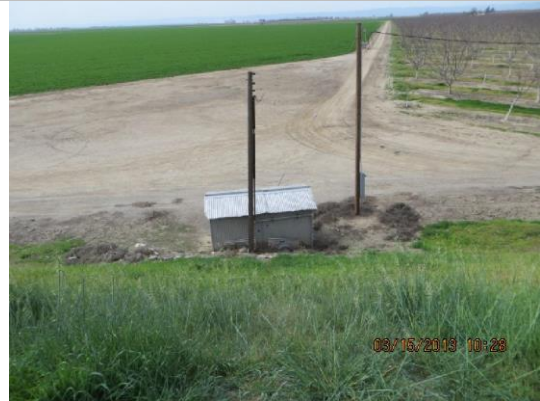
Photo 3 of 3 : UCIP_SP_2018_10325_17589.jpg

Item	DWR UCIP Field Study			39.066749 °	39.066749 °	
				-121.844987 °	-121.844987 °	
DWR ID						
Comment Code						
Inspector Comment						
FS_ID:10325 DS_ID:20317 EP_NO: 14495 Repair Type: Non-Urgent Crossing Status: Found UCIP Comments: Pipe may need flap gate at water side. FIELD_STRUCT_DESC: 22-inch steel drainage pipe through the levee, 3.8 feet below the crown. Pipe extends from existing pump house located at the landside (LS) toe through the levee to the low-water channel. Siphon breaker in 24-inch corrugated metal riser unit on LS shoulder. (22-inch pipe authorized under Permit No. 14495, 1986 - Jack Gross; 22-inch pipe replaced previous 12-inch and 16-inch pipes, installed under Automatic Board Order (ABO) issued as Permit No. 9358, 1974 - Crocker National Bank (Trustee)). FS Date: 3/15/2013

Pumphouse at LS toe.

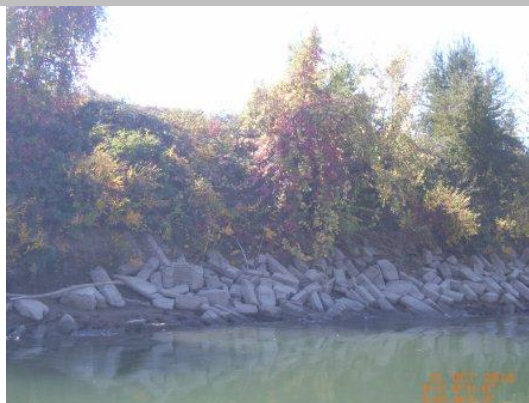
Photo 1 of 1 : SP_2018_NA0016_435_17_20180306_00015.jpg

LM Start	31.43	Rating **	M	Issue No.	17
LM End	31.45	Issue Type +	Ma	Location *	WS
Category	Supplemental			GPS Latitude/Longitude	
				Start	End
Item	2015 USACE Erosion Survey, DRAFT			39.067004 °	39.066901 °
				-121.866913 °	-121.867322 °
DWR ID	DWR_NA0016_01_s_2016_17				
Comment Code					
Inspector Comment					
1997 - Erosion into the levee section; old concrete rubble loss at toe; transition between the rock upstream and the cobble downstream. 2000 - Cohesive bench with concrete slabs on top; 25 ft deep scour hole on the downstream end. 2015: No observed changes. [2015 Site ID: SAC_123-7_R]

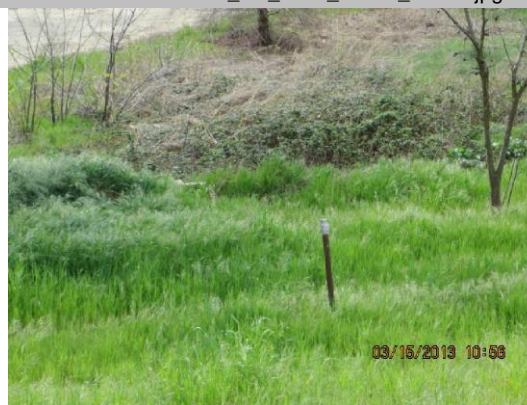
Photo 2 of 3 : UCIP_SP_2018_11543_18941.jpg

Siphon breaker on LS toe.

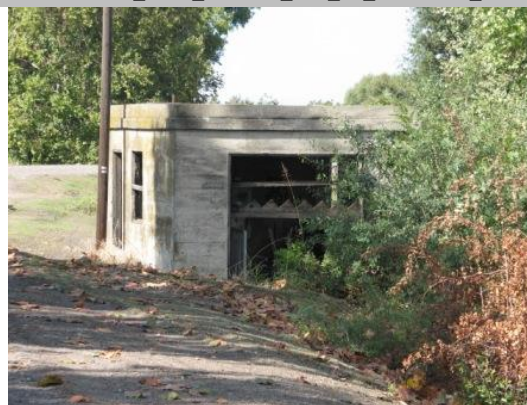
Photo 1 of 1 : SP_2018_NA0016_435_60_20180306_00031.jpg

LM Start	31.61	Rating **	M	Issue No.	60
LM End	31.61	Issue Type +	En	Location *	WS
Category	Earthen Levee			GPS Latitude/Longitude	
				Start	End
Item	Encroachments			39.066173 °	39.066173 °
				-121.870207 °	-121.870207 °
DWR ID	DWR_NA0016_01_s_2012_60				
Comment Code					
BU : Building					
Inspector Comment					
Abandoned pumphouse. Permitted under PN: 9338. Needs to be removed.

Old concrete pump house on the waterside levee slope. Fall 2011.

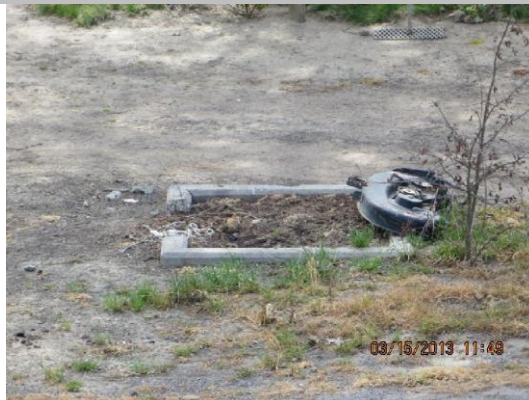
Photo 2 of 2 : UCIP_SP_2018_10364_17644.jpg

Comment Code						
Inspector Comment						
FS_ID:10364 DS_ID:20304 EP_NO: 9374 Repair Type: Non-Urgent Crossing Status: Found UCIP Comments: Need to verify type of abandonment FIELD_STRUCT_DESC: *ABANDONED* 2 of 4: 4-inch irrigation pipe of an unknown material through the levee, 6.5 feet below the crown. Gate valve on the waterside (WS) end. Siphon breaker inside a 24-inch corrugated metal riser unit on the landside (LS) slope. 4-foot by 4-foot concrete distribution box on the south side of Highway 45 at the LS toe. (Automatic Board Order (ABO) issued as Permit No. 9374, 1974 - Richard H. Moore). [Additional Reference(s): DWR Levee Log, 1980. USACE Sacramento O&M Manual 131, May 1960 (HLM 32.68)]. FS Date: 3/15/2013

Siphon Breaker in 25-inch CMP riser on LS slope with 4X4 concrete box off LS toe.

4X4 concrete box off LS toe.

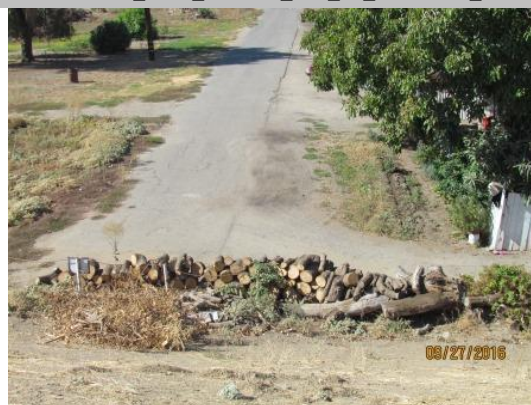
Photo 1 of 1 : SP_2018_NA0016_435_87_20180306_00035.jpg

LM Start	32.95	Rating **	M	Issue No.	87
LM End	32.95	Issue Type +	En	Location *	LS
Category	Earthen Levee			GPS Latitude/Longitude	
				Start	End
Item	Encroachments			39.074125 °	39.074125 °
				-121.891836 °	-121.891836 °
DWR ID	DWR_NA0016_01_f_2016_87				
Comment Code					
FW : Firewood					
Inspector Comment

Firewood within 10 feet of levee toe on landside. Fall 2016 inspection.

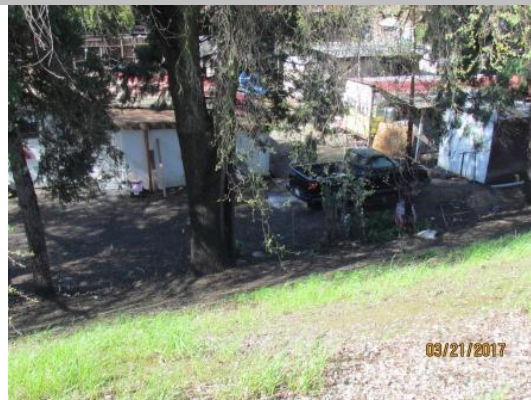
Photo 1 of 1 : SP_2018_NA0016_435_43_20180306_00027.jpg

LM Start	32.97	Rating **	M	Issue No.	43
LM End	32.97	Issue Type +	En	Location *	LS
Category	Earthen Levee			GPS Latitude/Longitude	
				Start	End
Item	Encroachments			39.074346 °	39.074346 °
				-121.892048 °	-121.892048 °
DWR ID	DWR_NA0016_01_s _ 2012_43				
Comment Code					
FE : Fence					
Inspector Comment					
Fence blocking access on landside toe.

Fence blocking access along landside levee toe. Spring 2017.

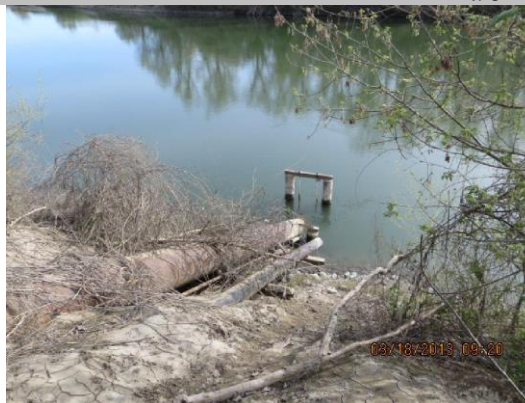
Photo 3 of 3 : UCIP_SP_2018_10403_17660.jpg

Comment Code					
Inspector Comment					
FS_ID:10403 DS_ID:20268 EP_NO: 9364A Repair Type: Non-Urgent Crossing Status: Found UCIP Comments: Pipe rusted through at concrete distribution box. May be indicator of pipe condition through levee. FIELD_STRUCT_DESC: 1 of 4: 16-inch steel irrigation pipe through the levee, 6.3 feet below the crown. Pump in pump house on the waterside (WS) end. Siphon breaker in a 36-inch steel riser unit on the landside (LS) slope. Discharges into a 5-foot by 9-foot concrete distribution box at the LS toe. (Automatic Board Order (ABO) issued as Permit No. 9364-A, 1974 - Alice Steidlmayer). (Installed by the United States Army Corp of Engineers, 1945). [Additional Reference(s): DWR Levee Log, 2006. USACE Sacramento O&M Manual 131, May 1960 (HLM 34.46)]. FS Date: 3/18/2013

Pipe at waters edge.

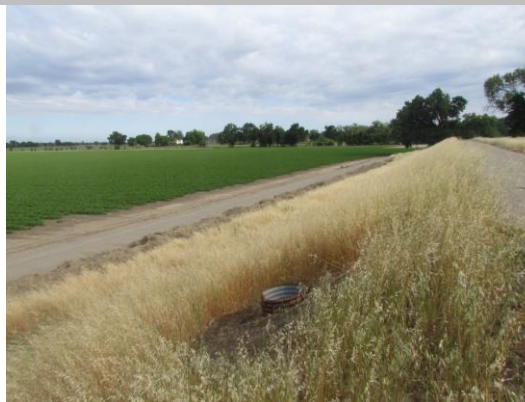
Photo 1 of 1 : SP_2018_NA0016_435_100_20180306_00042.jpg

LM Start	34.01	Rating **	M	Issue No.	100
LM End	34.07	Issue Type +	En	Location *	LS
Category	Earthen Levee			GPS Latitude/Longitude	
				Start	End
Item	Encroachments			39.087176 °	39.088099 °
				-121.896480 °	-121.896498 °
DWR ID	DWR_NA0016_01_s_2015_100				
Comment Code					
DT : Ditch					
Inspector Comment

View of the ditch at the landward side of the levee looking upstream. Spring 2015.

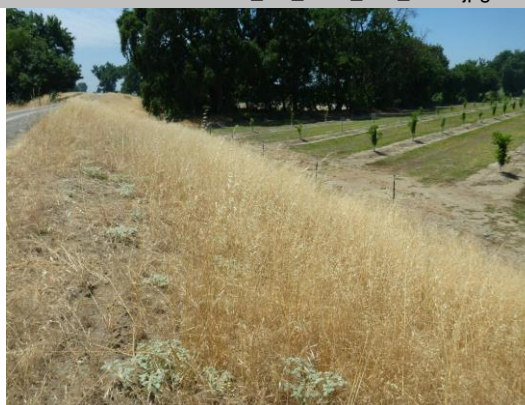
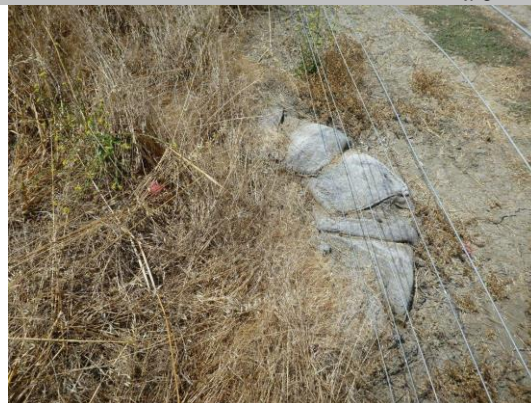
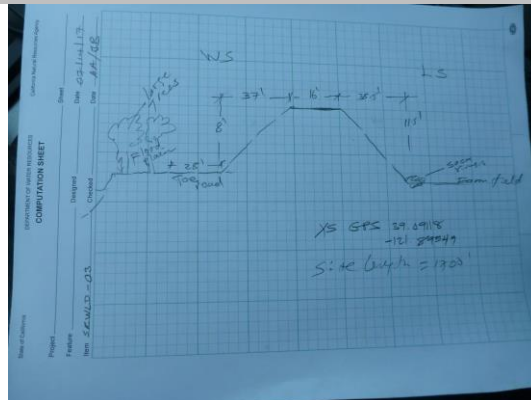
LM Start	34.24	Rating **	A/W	Issue No.	123
LM End	34.56	Issue Type +	Ob	Location *	
Category	Supplemental			GPS Latitude/Longitude	
				Start	End
Item	2017 Storm Damage			39.090511 °	39.094967 °
				-121.895675 °	-121.894858 °
DWR ID	DWR_NA0016_01_f_2017_123				
Comment Code					
Inspector Comment					
Levee Evaluation Comments					
Description:					
Site ID No:185					
Site Designation:SRWLD-03					
Repair Type: Seepage					
Rating:Critical					
Field Date:7/14/2017					
Notes: Well water tank 10' from LS toe & wire fence at LS toe

LM Start	34.24	Rating **	A/W	Issue No.	123 (cont)
LM End	34.56	Issue Type +	Ob	Location *	
Category	Supplemental		GPS Latitude/Longitude		
			Start	End	
Item	2017 Storm Damage		39.090511 °	39.094967 °	
			-121.895675 °	-121.894858 °	
DWR ID	DWR_NA0016_01_f_2017_123				
Comment Code					
Inspector Comment					
Levee Evaluation Comments					
Description:					
Site ID No:185					
Site Designation:SRWLD-03					
Repair Type: Seepage					
Rating:Critical					
Field Date:7/14/2017					
Notes: Well water tank 10' from LS toe & wire fence at LS toe

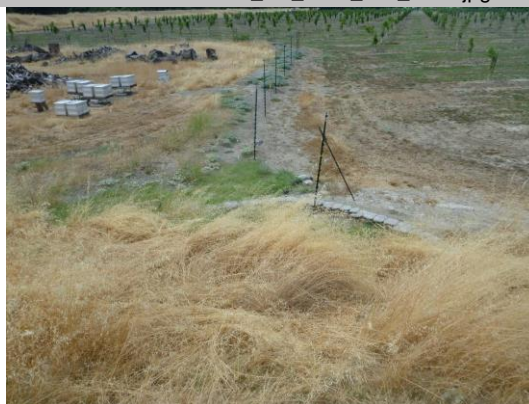
LM Start	34.65	Rating **	A/W	Issue No.	125
LM End	34.72	Issue Type +	Ob	Location *	
Category	Supplemental		GPS Latitude/Longitude		
			Start	End	
Item	2017 Storm Damage		39.095592 °	39.095589 °	
			-121.896103 °	-121.897400 °	
DWR ID	DWR_NA0016_01_f_2017_125				
Comment Code					
Inspector Comment					
Levee Evaluation Comments					
Description:					
Site ID No:184					
Site Designation:SRWLD-02					
Repair Type: Seepage					
Rating:Critical					
Field Date:7/14/2017					
Notes:

LM Start	34.65	Rating **	A/W	Issue No.	125 (cont)	
LM End	34.72	Issue Type +	Ob	Location *		
Category	Supplemental			GPS Latitude/Longitude		
				Start		End
Item	2017 Storm Damage			39.095592 °		39.095589 °
				-121.896103 °		-121.897400 °
DWR ID	DWR_NA0016_01_f_2017_125					
Comment Code						
Inspector Comment						
Levee Evaluation Comments						
Description:						
Site ID No:184						
Site Designation:SRWLD-02						
Repair Type: Seepage						
Rating:Critical						
Field Date:7/14/2017						
Notes:

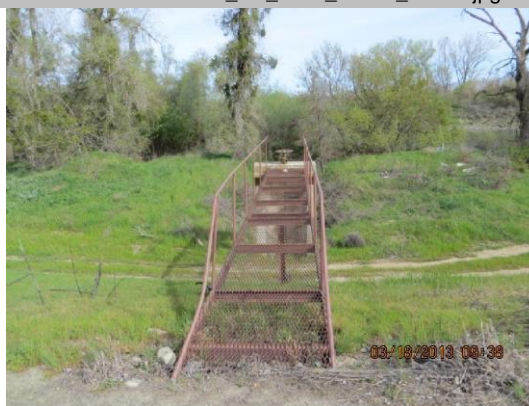
Photo 1 of 3 : UCIP_SP_2018_10406_17666.jpg

LM Start	34.72	Rating **	A/W	Issue No.	1597
LM End	34.72	Issue Type +	Ma	Location *	
Category	Supplemental			GPS Latitude/Longitude	
				Start	End
Item	DWR UCIP LMA Responsibility			39.095621 °	39.095621 °
				-121.897340 °	-121.897340 °
DWR ID					
Comment Code					
Inspector Comment					
FS_ID:10406 DS_ID:20270 EP_NO: 494 Repair Type: No Action Needed Crossing Status: Found UCIP Comments: FIELD_STRUCT_DESC: 48-inch corrugated metal drainage pipe through the levee, 23 feet below the crown. Slide gate on concrete headwall on the waterside (WS) end. Walkway provided to control gate. (Permit No. 494, 1930 - S. L. Cecil). (Automatic Board Order (ABO) issued as Permit No. 9363, 1974 - S. L. Cecil). [Additional Reference(s): DWR Levee Log, 2006. USACE Sacramento O&M Manual 131, May 1960 (HLM 35.18)]. FS Date: 3/18/2013

Walkway to slidegate on WS berm.

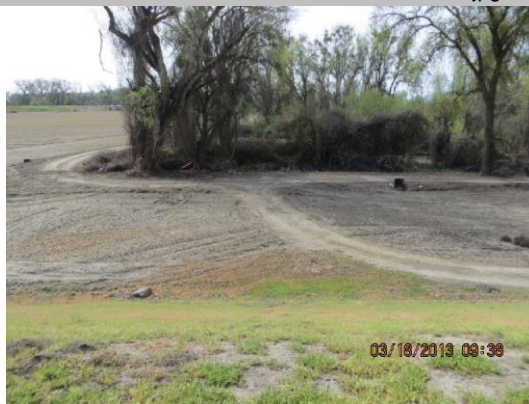
Photo 2 of 3 : UCIP_SP_2018_10406_17665.jpg

Inlet in vegetated area off LS toe.

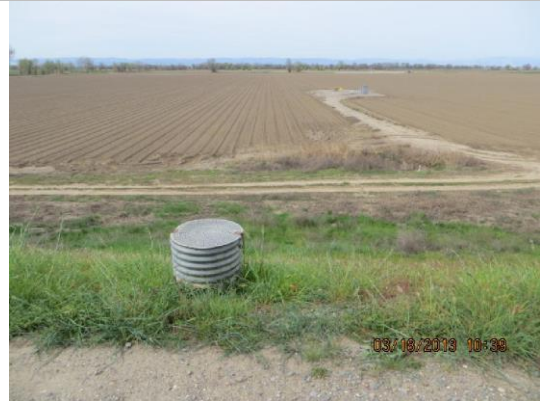
Photo 1 of 1 : UCIP_SP_2018_10424_17700.jpg

LM Start	35.56	Rating **	M	Issue No.	1598
LM End	35.56	Issue Type +	En	Location *	
Category	Supplemental			GPS Latitude/Longitude	
				Start	End
Item	DWR UCIP Field Study			39.103533 °	39.103533 °
				-121.906814 °	-121.906814 °
DWR ID					
Comment Code					
Inspector Comment					
FS_ID:10424 DS_ID:20273 EP_NO: 9364A Repair Type: Non-Urgent Crossing Status: Found UCIP Comments: Need to verify type of abandonment. FIELD_STRUCT_DESC: 3 of 4: 18-inch steel irrigation pipe through the levee, 16 feet below the crown. Metal cutoff wall. Gate valve on the waterside (WS) bank. Siphon breaker in a 24-inch corrugated metal riser unit on the landside (LS) shoulder. (Automatic Board Order (ABO) issued as Permit No. 9364-A, 1974 - Alice Steidlmayer). [Additional Reference(s): DWR Levee Log, 2006. USACE Sacramento O&M Manual 131, May 1960 (HLM 36.04)]. FS Date: 3/18/2013

Siphon breaker in 24-inch CMP riser on LS shoulder.

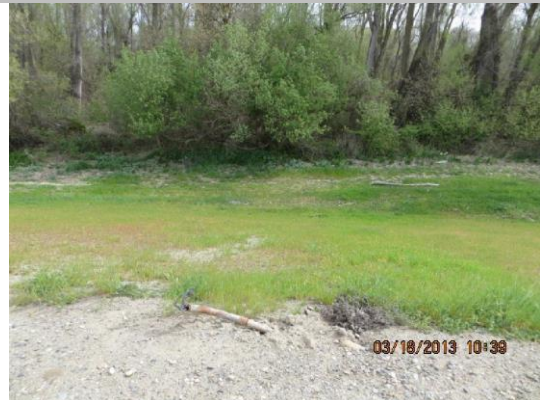
Photo 1 of 2 : UCIP_SP_2018_10425_17702.jpg

LM Start	35.56	Rating **	M	Issue No.	1599	
LM End	35.56	Issue Type +	En	Location *		
Category	Supplemental			GPS Latitude/Longitude		
				Start	End	
Item	DWR UCIP Field Study			39.103533 °	39.103533 °	
				-121.906814 °	-121.906814 °	
DWR ID						
Comment Code						
Inspector Comment						
FS_ID:10425 DS_ID:20398 EP_NO: 9364 Repair Type: Non-Urgent Crossing Status: Found UCIP Comments: Remove abandoned pipe from levee. FIELD_STRUCT_DESC: *ABANDONED* 4 of 4: 1.25-inch electrical conduit of an unknown material through the levee, 3 feet below the crown. (Automatic Board Order (ABO) issued as Permit No. 9364-A, 1974 - Alice Steidlmayer). FS Date: 3/18/2013

Electrical conduit on WS shoulder.

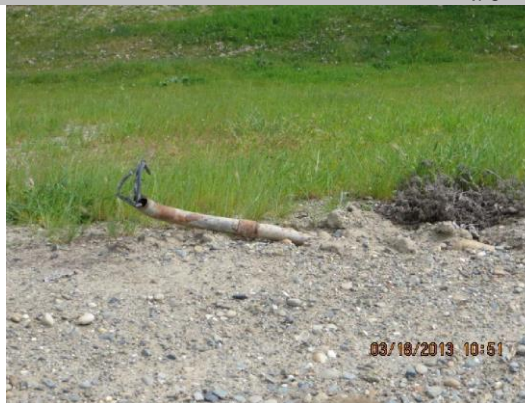
Photo 2 of 2 : UCIP_SP_2018_10425_17701.jpg

LM Start	35.56	Rating **	M	Issue No.	1599 (cont)
LM End	35.56	Issue Type +	En	Location *	
Category	Supplemental		GPS Latitude/Longitude		
			Start	End	
Item	DWR UCIP Field Study		39.103533 °	39.103533 °	
			-121.906814 °	-121.906814 °	
DWR ID					
Comment Code					
Inspector Comment					
FS_ID:10425 DS_ID:20398 EP_NO: 9364 Repair Type: Non-Urgent Crossing Status: Found UCIP Comments: Remove abandoned pipe from levee. FIELD_STRUCT_DESC: *ABANDONED* 4 of 4: 1.25-inch electrical conduit of an unknown material through the levee, 3 feet below the crown. (Automatic Board Order (ABO) issued as Permit No. 9364-A, 1974 - Alice Steidlmayer). FS Date: 3/18/2013

Electrical conduit on WS shoulder.

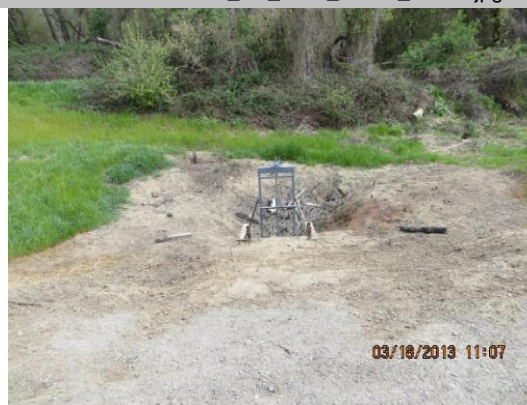
Photo 1 of 3 : UCIP_SP_2018_10426_17705.jpg

Comment Code					
Inspector Comment					
FS_ID:10426 DS_ID:20345 EP_NO: 9374 Repair Type: Non-Urgent Crossing Status: Found UCIP Comments: Verify if pipe is abandoned with landowner and remove or abandon properly if necessary. FIELD_STRUCT_DESC: *ABANDONED* 3 of 3: 24-inch concrete encased steel drainage pipe through the levee, 17 feet below the crown. Slide gate on concrete headwall on waterside (WS) end. Walkway to control gate and gate valve on landside (LS) end. (24-inch pipe [HLM 36.61] authorized under Automatic Board Order (ABO) issued as Permit No. 9374, 1974 - Richard H. Moore). [Additional Reference(s): USACE Sacramento O&M Manual 131, May 1960 (HLM 36.61)]. FS Date: 3/18/2013

Slide gate on WS toe.

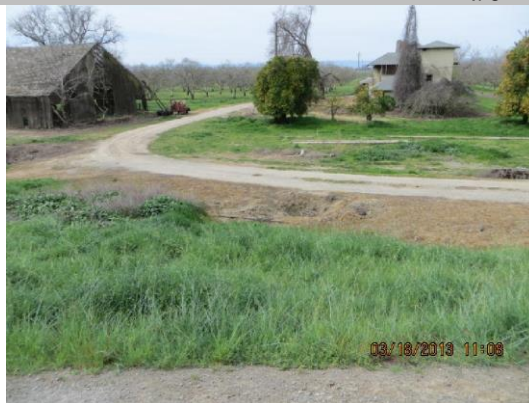
Photo 2 of 3 : UCIP_SP_2018_10426_17704.jpg

Item	DWR UCIP LMA Responsibility			39.111233	°	
				-121.911450	°	
DWR ID						
Comment Code						
Inspector Comment						
FS_ID:10426 DS_ID:20345 EP_NO: 9374 Repair Type: Non-Urgent Crossing Status: Found UCIP Comments: Verify if pipe is abandoned with landowner and remove or abandon properly if necessary. FIELD_STRUCT_DESC: *ABANDONED* 3 of 3: 24-inch concrete encased steel drainage pipe through the levee, 17 feet below the crown. Slide gate on concrete headwall on waterside (WS) end. Walkway to control gate and gate valve on landside (LS) end. (24-inch pipe [HLM 36.61] authorized under Automatic Board Order (ABO) issued as Permit No. 9374, 1974 - Richard H. Moore). [Additional Reference(s): USACE Sacramento O&M Manual 131, May 1960 (HLM 36.61)]. FS Date: 3/18/2013

Headwall and gate valve on LS toe buried but partially exposed.

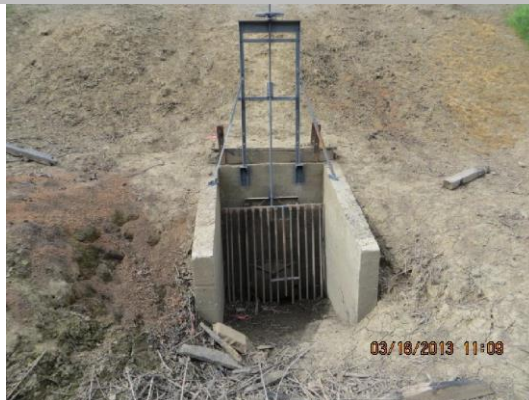
Photo 3 of 3 : UCIP_SP_2018_10426_17703.jpg

Outlet/inlet on WS toe.

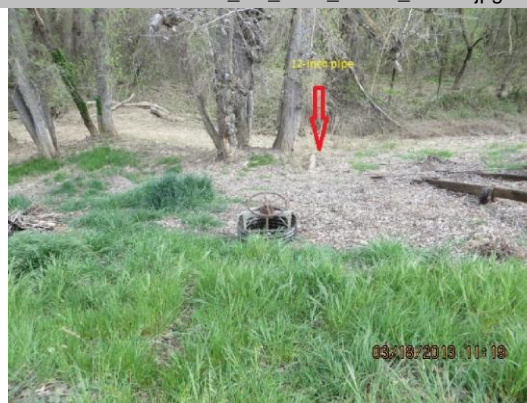
Photo 1 of 3 : UCIP_SP_2018_10444_17725.jpg

Comment Code					
Inspector Comment					
FS_ID:10444 DS_ID:20274 EP_NO: 9374 Repair Type: Non-Urgent Crossing Status: Found UCIP Comments: Pipe should be abandoned properly. FIELD_STRUCT_DESC: 4 of 4: 24-inch corrugated metal irrigation pipe through the levee, 15.5 feet below the crown. Two corrugated metal cutoff walls. Slide gate in a 36-inch corrugated metal riser unit on the waterside (WS) slope. Pump house with no connection on the WS bank. 12-inch steel pipe with steel plate over end at WS toe (likely pump connection point). 6-foot diameter concrete riser on landside (LS) toe. Skid rails mounted on wood piling on the WS slope. Department of Water Resources B.M. SR 47 on top of concrete anchor post on the WS shoulder. Power pole and meter box on the WS shoulder. Switch panel in metal house on the WS slope. Concrete standpipe on the LS. Overhead power line crosses the levee to service pole. (Automatic Board Order (ABO) issued as Permit No. 9374, 1974 - Richard H. Moore). [Additional Reference(s): DWR Levee Log, 2006]. FS Date: 3/18/2013 7:51:00 AM

36-inch CMP riser with slide gate on WS slope with 12-inch pipe at Toe.

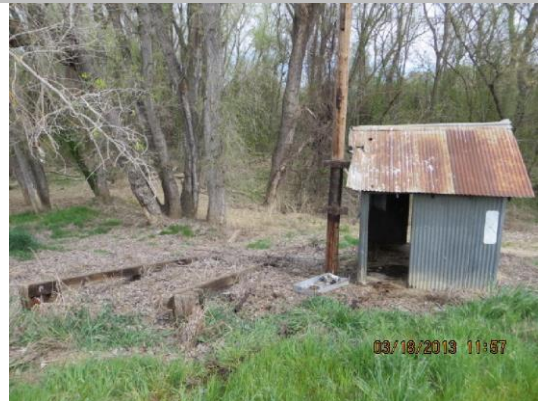
Photo 3 of 3 : UCIP_SP_2018_10444_17723.jpg

Item	DWR UCIP Field Study			39.112377 °	39.112377 °	
				-121.912286 °	-121.912286 °	
DWR ID						
Comment Code						
Inspector Comment						
FS_ID:10444 DS_ID:20274 EP_NO: 9374 Repair Type: Non-Urgent Crossing Status: Found UCIP Comments: Pipe should be abandoned properly. FIELD_STRUCT_DESC: 4 of 4: 24-inch corrugated metal irrigation pipe through the levee, 15.5 feet below the crown. Two corrugated metal cutoff walls. Slide gate in a 36-inch corrugated metal riser unit on the waterside (WS) slope. Pump house with no connection on the WS bank. 12-inch steel pipe with steel plate over end at WS toe (likely pump connection point). 6-foot diameter concrete riser on landside (LS) toe. Skid rails mounted on wood piling on the WS slope. Department of Water Resources B.M. SR 47 on top of concrete anchor post on the WS shoulder. Power pole and meter box on the WS shoulder. Switch panel in metal house on the WS slope. Concrete standpipe on the LS. Overhead power line crosses the levee to service pole. (Automatic Board Order (ABO) issued as Permit No. 9374, 1974 - Richard H. Moore). [Additional Reference(s): DWR Levee Log, 2006]. FS Date: 3/18/2013 7:51:00 AM

Pump house, JP, and wooden ramp on WS slope.

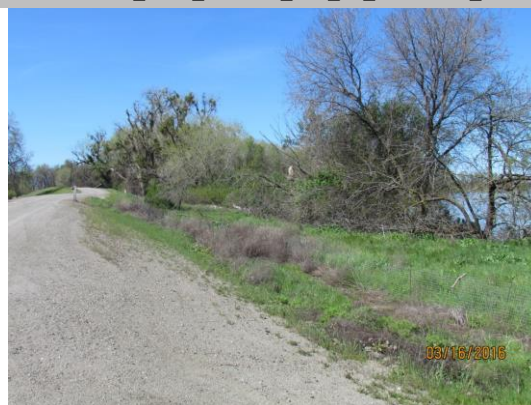
Photo 1 of 2 : SP_2018_NA0016_435_33_20180306_00025.jpg

LM Start	37.07	Rating **	A/W	Issue No.	33
LM End	37.15	Issue Type +	Ob	Location *	WS
Category	Earthen Levee			GPS Latitude/Longitude	
				Start	End
Item	Vegetation			39.121003 °	39.121547 °
				-121.919888 °	-121.921278 °
DWR ID	DWR_NA0016_01_s_2012_33				
Comment Code					
V8 : Environmental Requirements.					
Inspector Comment					
Revegetation site is fenced off.

View of the revegetation site on the waterward berm of the levee looking upstream. Spring 2016.

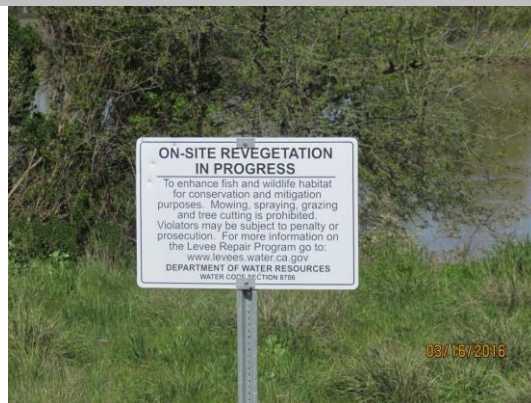
Photo 2 of 2 : SP_2018_NA0016_435_33_20180306_00026.jpg

Sign stating the revegetation site. Spring 2016.

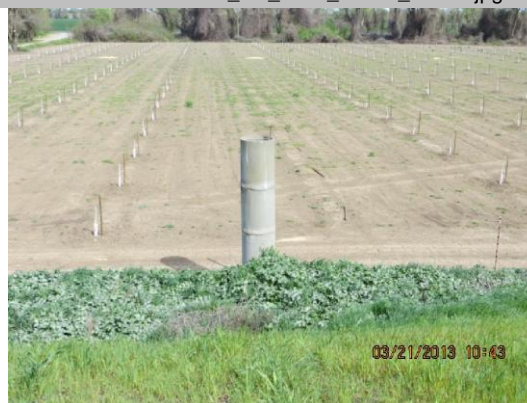
Photo 1 of 3 : UCIP_SP_2018_10528_17854.jpg

Comment Code						
Inspector Comment						
FS_ID:10528 DS_ID:20282 EP_NO: 9352 Repair Type: Non-Urgent Crossing Status: Found UCIP Comments: Pipe appears to have been removed from levee section. Need to verify pipe abandonment. FIELD_STRUCT_DESC: 12-inch steel irrigation pipe through the levee, 5 feet below the crown. Switch house on the waterside (WS) shoulder. Pump and gate valve on the WS bank. Concrete discharge standpipe on the landside (LS). (For a 14-inch pipe, Permit No. 635, 1935 - Henry F. Schmidt). (Automatic Board Order (ABO) issued as Permit No. 9351, 1974 - W. A. Gerrans). [Additional Reference(s): DWR Levee Log, 2006. USACE Sacramento O&M Manual 131, May 1960 (HLM 40.43)]. FS Date: 3/21/2013

Concrete standpipe at LS toe.

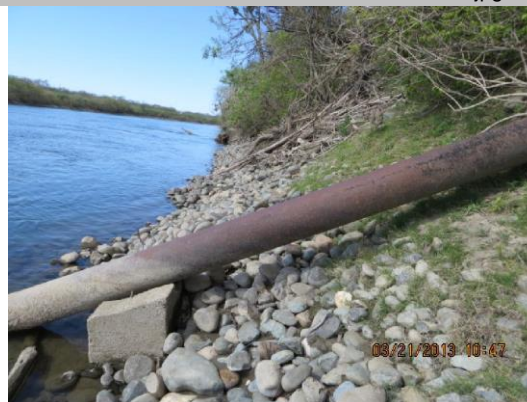
Photo 2 of 3 : UCIP_SP_2018_10528_17853.jpg

Pipe visible at WS toe.

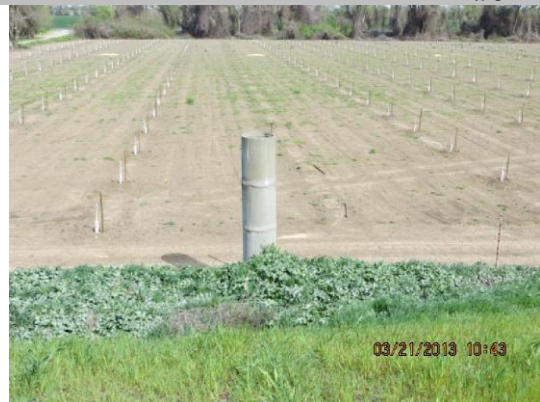
Photo 1 of 2 : UCIP_SP_2018_11343_18741.jpg

LM Start	39.93	Rating **	M	Issue No.	1603
LM End	39.93	Issue Type +	En	Location *	
Category	Supplemental			GPS Latitude/Longitude	
				Start	End
Item	DWR UCIP Field Study			39.143387 °	39.143387 °
				-121.927196 °	-121.927196 °
DWR ID					
Comment Code					
Inspector Comment					
FS_ID:11343 DS_ID:22966 EP_NO: 9352 Repair Type: Non-Urgent Crossing Status: Found UCIP Comments: Pipe should be removed. FIELD_STRUCT_DESC: 1.5-inch galvanized steel electrical conduit through the levee, at an unknown depth. Visible on the waterside (WS) slope. (Permit No. 635, 1935 - Henry F. Schmidt). FS Date: 3/21/2013

Electrical conduit approximately perpendicular to concrete riser on LS toe.

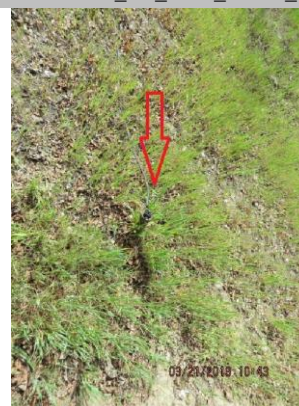
Photo 2 of 2 : UCIP_SP_2018_11343_18740.jpg

1.5-inch electrical conduit on WS slope.

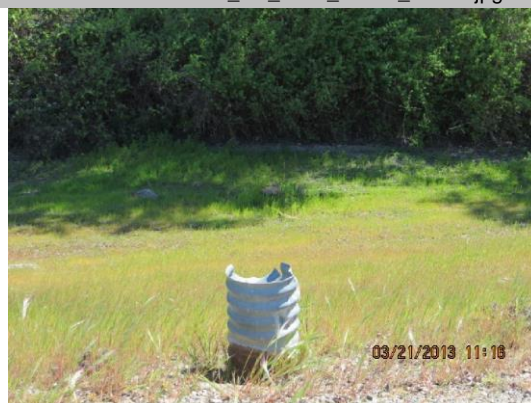
Photo 1 of 3 : UCIP_SP_2018_10527_17850.jpg

LM Start	40.44	Rating **	M	Issue No.	1604	
LM End	40.44	Issue Type +	En	Location *		
Category	Supplemental			GPS Latitude/Longitude		
				Start	End	
Item	DWR UCIP Field Study			39.143838 °	39.143838 °	
				-121.919338 °	-121.919338 °	
DWR ID						
Comment Code						
Inspector Comment						
FS_ID:10527						
DS_ID:20285						
EP_NO: 12799						
Repair Type: Non-Urgent						
Crossing Status: Found						
UCIP Comments: Pipe appears abandoned. Need to verify type of abandonment						
FIELD_STRUCT_DESC: 18-inch steel irrigation pipe through the levee, 6.5 feet below the crown. 30-inch corrugated metal standpipe on landside (LS) toe. Pump on the waterside (WS) toe. Vent inside a 12-inch corrugated metal riser unit on the WS shoulder. (Permit No. 12799, 1979 - Bruce Myers). [Additional Reference(s): DWR Levee Log, 2006].						
FS Date: 3/21/2013

Vent in 12-inch CMP riser on WS shoulder.

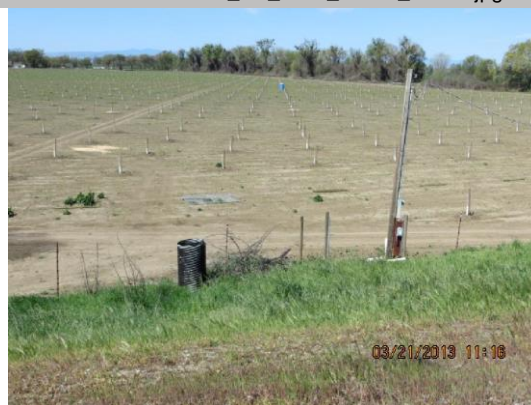
Photo 2 of 3 : UCIP_SP_2018_10527_17849.jpg

30-inch CMP riser with slide gate at LS toe.

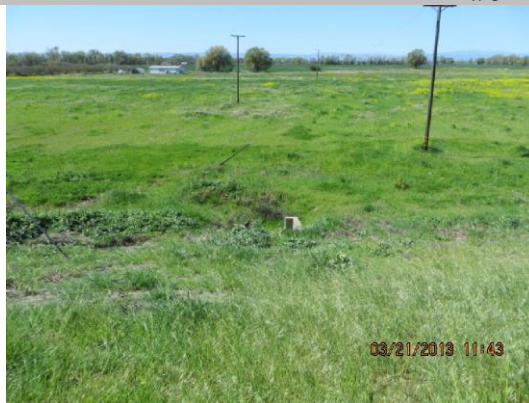
Photo 1 of 3 : UCIP_SP_2018_10533_17865.jpg

Comment Code					
Inspector Comment					
FS_ID:10533 DS_ID:20287 EP_NO: 9351 Repair Type: Non-Urgent Crossing Status: Found UCIP Comments: Appears abandoned. Should be abandoned properly. FIELD_STRUCT_DESC: 30-inch corrugated metal irrigation pipe through the levee, 17.5 feet below the crown. Slide gate on the waterside (WS) end. Discharges into a concrete box at the landside (LS) toe. Small pump discharges into a sump area in front of slide gate at WS toe. (Automatic Board Order (ABO) issued as Permit No. 9351, 1974 - W. A. Gerrans). [Additional Reference(s): DWR Levee Log, 2006. USACE Sacramento O&M Manual 131, May 1960 (HLM 41.39)]. FS Date: 3/21/2013

Demolished concrete distribution box at LS toe.

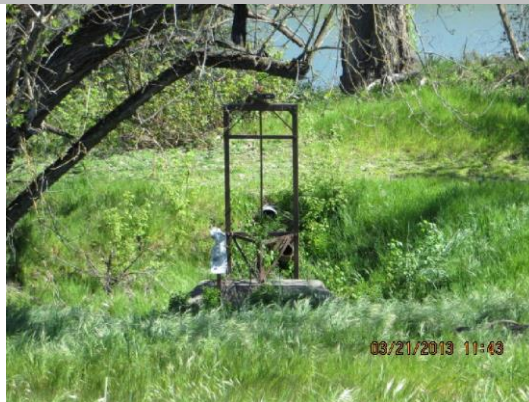
Photo 2 of 3 : UCIP_SP_2018_10533_17864.jpg

Slide gate at WS toe.

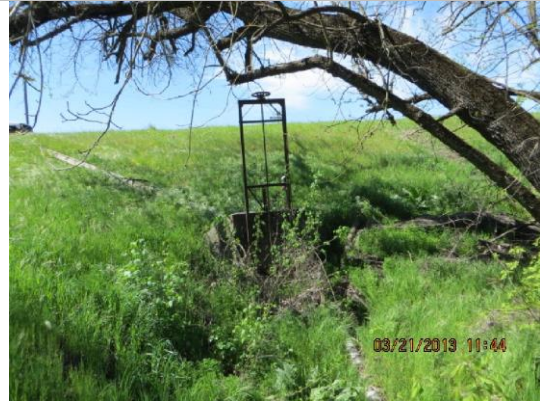
Photo 3 of 3 : UCIP_SP_2018_10533_17863.jpg

Slide gate at WS toe.

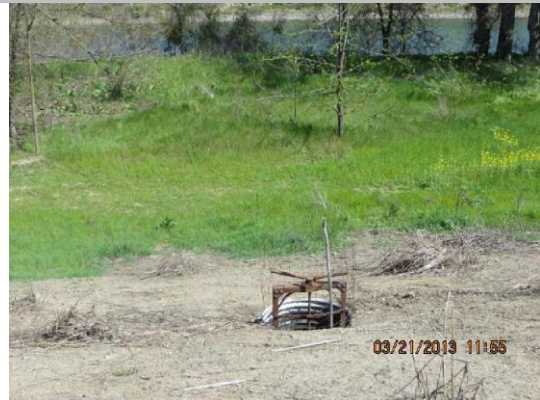
Photo 1 of 3 : UCIP_SP_2018_10535_17877.jpg

Comment Code						
Inspector Comment						
FS_ID:10535 DS_ID:20288 EP_NO: N/A Repair Type: No Action Needed Crossing Status: Found UCIP Comments: FIELD_STRUCT_DESC: 24-inch drainage pipe of an unknown material through the levee, 19 feet below the crown. 6-foot diameter corrugated metal standpipe on the landside (LS) toe. Pump and 24-inch pipe on the LS. Slide gate in corrugated metal riser unit on waterside (WS) slope. Concrete block wall at WS toe for discharge line. (Modified under Permit No. 8587, 1973 - Anthony E. Steidlmyer). [Additional Reference(s): DWR Levee Log, 2006. USACE Sacramento O&M Manual 131, May 1960 (HLM 41.56)]. FS Date: 3/21/2013

Slide gate in CMP riser on WS slope.

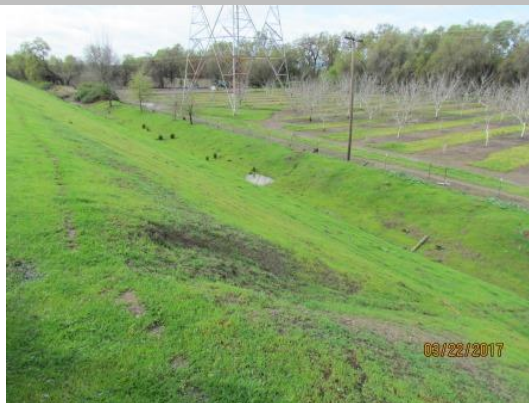
Photo 1 of 2 : SP_2018_NA0016_435_146_20180306_00070.jpg

LM Start	42.73	Rating **	A/W	Issue No.	146
LM End	42.73	Issue Type +	Ma	Location *	LS
Category	Earthen Levee			GPS Latitude/Longitude	
				Start	End
Item	Slope Stability			39.169949 °	39.169949 °
				-121.938664 °	-121.938664 °
DWR ID	DWR_NA0016_01_f_2015_146				
Comment Code					
S2 : Repair the levee slope damaged by foot traffic and prevent access where possible.					
Inspector Comment

Slope stability issue due to foot traffic. Spring 2017.

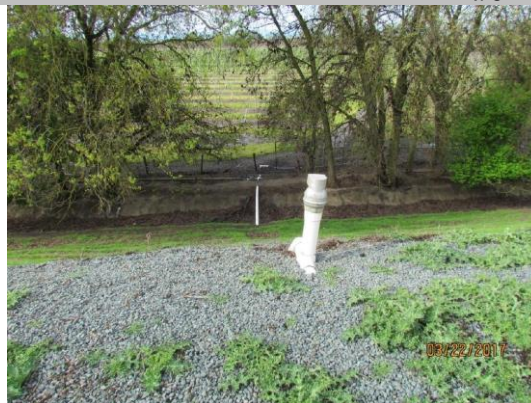
Photo 1 of 3 : UCIP_SP_2018_52625_76995.jpg

Comment Code						
Inspector Comment						
FS_ID:52625 DS_ID:25485 EP_NO: N/A Repair Type: Non-Urgent Crossing Status: Found UCIP Comments: 05/23/2018 Contacted NA0016 superintendent about history and current status of the crossing. Confirmed that LMA has no additional information about this crossing that was put in before spring of 2017 (DWR UCIP-O.Yakimov) FIELD_STRUCT_DESC: 4-inch polyvinyl chloride (PVC) irrigation pipe through the levee, of an unknown depth below crown. Siphon breaker off landside (LS) shoulder. The pipe irrigates landscape on the waterside of the levee and is not permitted. Pipe found by DWR inspector Zach Jojola during Spring 2017 inspection. FS Date: 4/20/2017

LS view of siphon breaker off LS shoulder. Photo courtesy of Zach Jojola, DWR inspector.

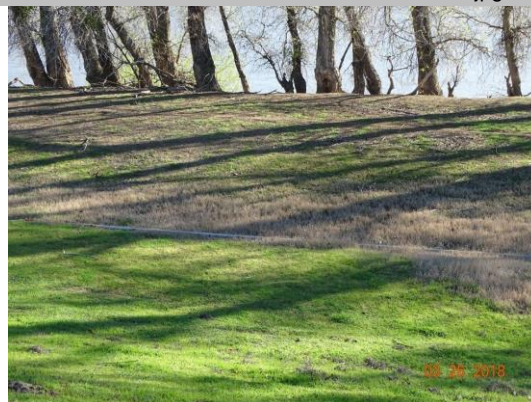
Photo 2 of 3 : UCIP_SP_2018_52625_77553.jpg

Sprinkler system on the waterside berm. Spring 2018 inspection, photo courtesy of Zach Jojola.

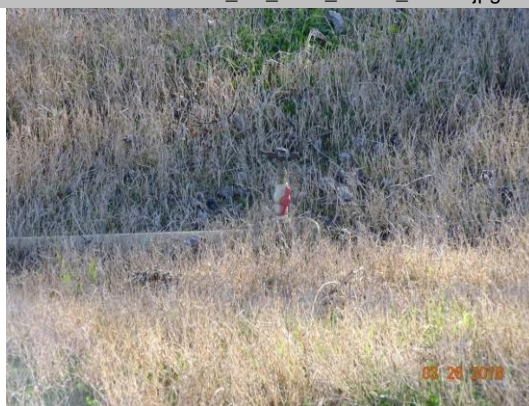
Photo 3 of 3 : UCIP_SP_2018_52625_77554.jpg

Sprinkler system on the waterside berm. Spring 2018 inspection, photo courtesy of Zach Jojola.

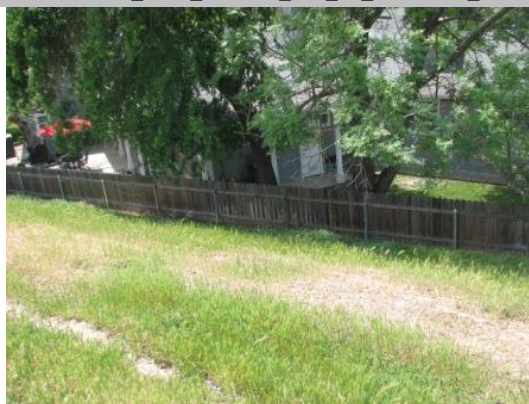
Photo 1 of 1 : SP_2018_NA0016_435_46_20180306_00028.jpg

LM Start	43.24	Rating **	M	Issue No.	46
LM End	43.24	Issue Type +	En	Location *	LS
Category	Earthen Levee			GPS Latitude/Longitude	
				Start	End
Item	Encroachments			39.176429 °	39.176429 °
				-121.942889 °	-121.942889 °
DWR ID	DWR_NA0016_01_s_2012_46				
Comment Code					
FE : Fence					
Inspector Comment

A solid fence along the toe of the levee. Photo taken spring 2012.

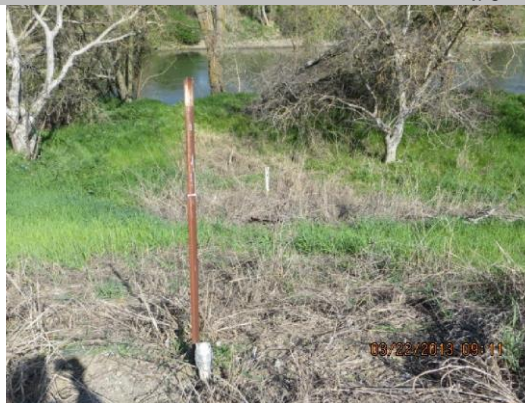
Photo 1 of 3 : UCIP_SP_2018_46812_17909.jpg

Comment Code						
Inspector Comment						
FS_ID:46812 DS_ID:20314 EP_NO: 15763 Repair Type: Non-Urgent Crossing Status: Found UCIP Comments: Fresno valve on WS shoulder is broken. Pipe appears to be abandoned. Need to abandon properly if necessary. site visit on 10/09/2015 indicates water is present somewhere along the waterside levee slope. Possibly siphon breaker or fresno valve sprays and drains down levee slope from WS shoulder. internal inspection of pipe recommended to determine source of leak. Pipe is active, but can be removed and capped when not in use. FIELD_STRUCT_DESC: 4-inch galvanized steel irrigation pipe through the levee, 2 feet below the crown. Irrigation valve approximately 50 feet landward of the landside (LS) toe. Fresno valve on the waterside (WS) shoulder with connection for pump at the WS berm. (Permit No. 15763, 1991 - Randy Salverson). FS Date: 3/22/2013

Broken fresno valve on WS shoulder

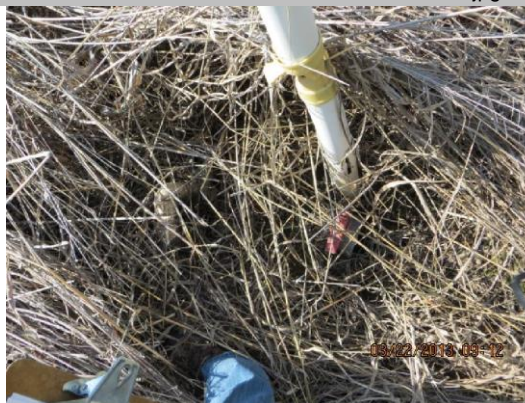
Photo 2 of 3 : UCIP_SP_2018_46812_17908.jpg

Pipe connection at WS toe.

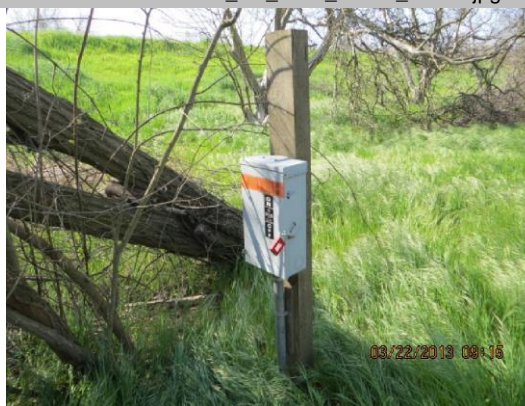
Photo 3 of 3 : UCIP_SP_2018_46812_17907.jpg

Electrical box at WS berm for portable pump.

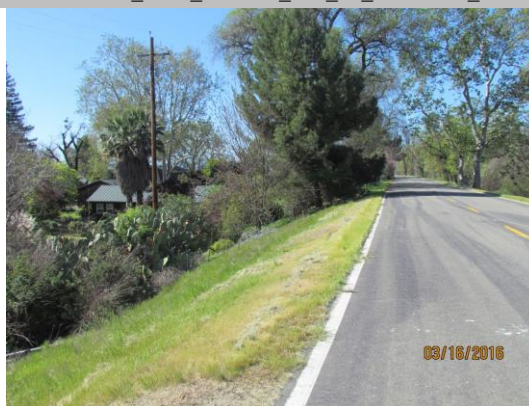
Photo 1 of 1 : SP_2018_NA0016_435_54_20180306_00029.jpg

LM Start	47.01	Rating **	M	Issue No.	54
LM End	47.14	Issue Type +	En	Location *	LS
Category	Earthen Levee			GPS Latitude/Longitude	
				Start	End
Item	Vegetation			39.188544 °	39.189733 °
				-121.979272 °	-121.981232 °
DWR ID	DWR_NA0016_01_s_2012_54				
Comment Code					
V6 : Landscaping					
Inspector Comment					
Cactus on slope and toe of levee, landscape continues along roadway with fence and stairs.

View of the revegetation on the landward side of the levee looking upstream. Spring 2016.

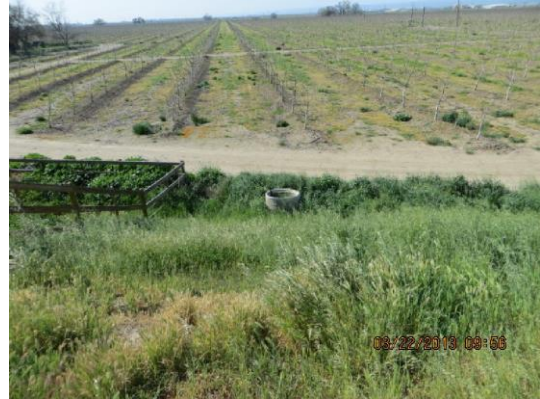
Photo 1 of 1 : UCIP_SP_2018_10553_17929.jpg

Comment Code					
Inspector Comment					
FS_ID:10553 DS_ID:20298 EP_NO: 9347 Repair Type: Non-Urgent Crossing Status: Indicator Found UCIP Comments: Need to verify type of abandonment. FIELD_STRUCT_DESC: 1 of 2: 24-inch irrigation pipe of an unknown material through the levee, 25.5 feet below the crown. 14-inch pipe sleeved through 24-inch pipe. Annular space grouted. Pump inside pump house on the landside (LS). Gate valve inside pump house on the LS. (Automatic Board Order (ABO) issued as Permit No. 9347, 1974 - Floremon Orchards). [Additional Reference(s): DWR Levee Log, 2006. USACE Sacramento O&M Manual 131, May 1960 (HLM 47.71)]. FS Date: 3/22/2013

Possible location for pipe crossing.

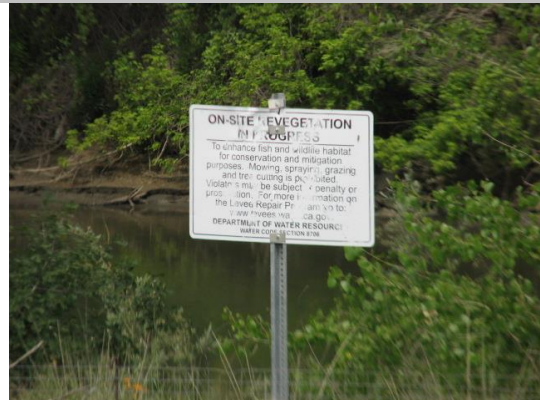
Photo 1 of 1 : SP_2018_NA0016_435_90_20180306_00036.jpg

LM Start	47.19	Rating **	A/W	Issue No.	90
LM End	47.62	Issue Type +	Ob	Location *	WS
Category	Earthen Levee			GPS Latitude/Longitude	
				Start	End
Item	Vegetation			39.189930 °	39.193491 °
				-121.982143 °	-121.988184 °
DWR ID	DWR_NA0016_01_s_2014_90				
Comment Code					
V8 : Environmental Requirements.					
Inspector Comment

A revegetation site along the waterside berm. Spring 2014

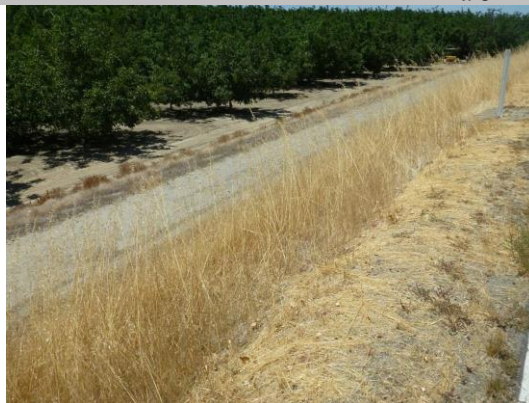
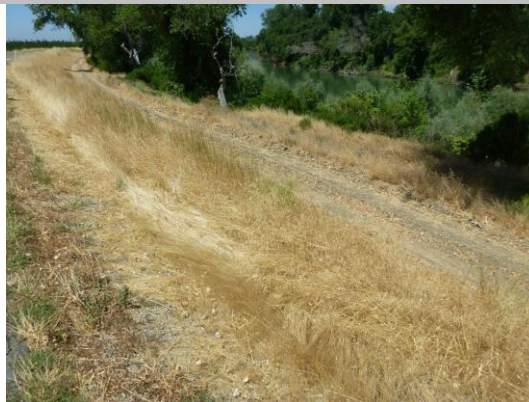
LM Start	47.43	Rating **	A/W	Issue No.	126	
LM End	47.53	Issue Type +	Ob	Location *		
Category	Supplemental			GPS Latitude/Longitude		
				Start	End	
Item	2017 Storm Damage			39.191283 °	39.192405 °	
				-121.986205 °	-121.987320 °	
DWR ID	DWR_NA0016_01_f_2017_126					
Comment Code						
Inspector Comment						
Levee Evaluation Comments						
Description:						
Site ID No:187						
Site Designation:SRWLD-05						
Repair Type: Seepage						
Rating:Area of Concern						
Field Date:7/14/2017						
Notes: Berm on LS levee slope

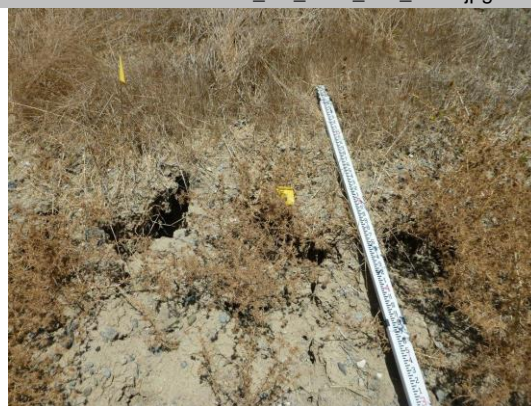
Photo 3 of 3 : LEVAL_SP_2018_187_1654.jpg

LM Start	47.43	Rating **	A/W	Issue No.	126 (cont)	
LM End	47.53	Issue Type +	Ob	Location *		
Category	Supplemental			GPS Latitude/Longitude		
				Start	End	
Item	2017 Storm Damage			39.191283 °	39.192405 °	
				-121.986205 °	-121.987320 °	
DWR ID	DWR_NA0016_01_f_2017_126					
Comment Code						
Inspector Comment						
Levee Evaluation Comments						
Description:						
Site ID No:187						
Site Designation:SRWLD-05						
Repair Type: Seepage						
Rating:Area of Concern						
Field Date:7/14/2017						
Notes: Berm on LS levee slope

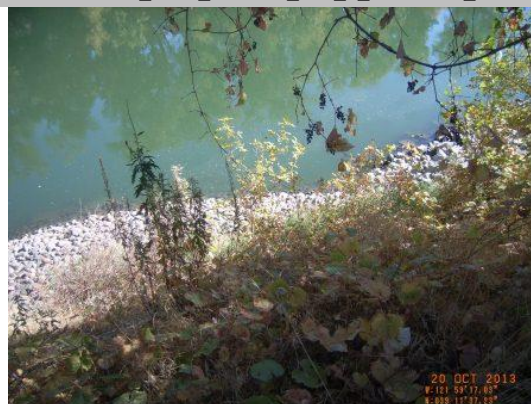
Photo 1 of 1 : SP_2018_NA0016_435_3_20180306_00003.jpg

LM Start	47.62	Rating **	A/W	Issue No.	3
LM End	47.77	Issue Type +	Ma	Location *	WS
Category	Supplemental			GPS Latitude/Longitude	
				Start	End
Item	2015 USACE Erosion Survey, DRAFT			39.193769 °	39.195595 °
				-121.987901 °	-121.988621 °
DWR ID	DWR_NA0016_01_s_2016_3				
Comment Code					
Inspector Comment					
2010 - Old cobble site starting to unravel at toe. 2011 - Cobbles continue to unravel. 2013 - Site extended downstream to revetment. 2015: No observed changes. [2015 Site ID: SAC_141-5_R]

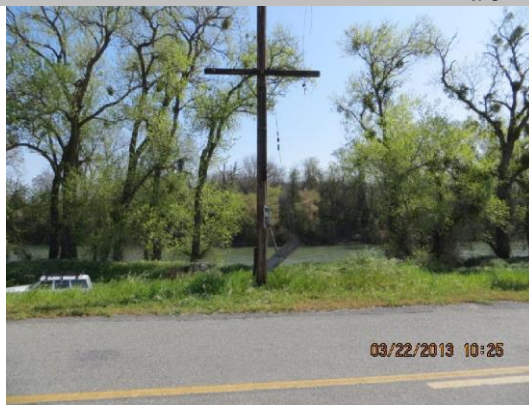
Photo 2 of 2 : UCIP_SP_2018_10563_17940.jpg

JP on WS shoulder for removed pump switch house.

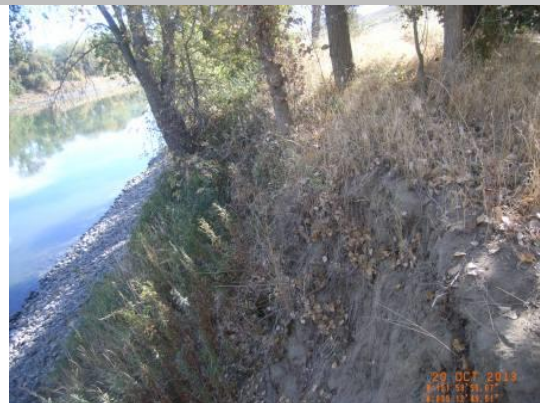
Photo 1 of 1 : SP_2018_NA0016_435_19_20180306_00016.jpg

LM Start	49.46	Rating **	M	Issue No.	19
LM End	49.57	Issue Type +	Ma	Location *	WS
Category	Supplemental			GPS Latitude/Longitude	
				Start	End
Item	2015 USACE Erosion Survey, DRAFT			39.213608 °	39.213869 °
				-121.997543 °	-121.999641 °
DWR ID	DWR_NA0016_01_s_2016_19				
Comment Code					
Inspector Comment					
2011 - Multiple scallops, one tree pop out. Old cobble site starting to unravel at midbank. 2012 - Mid bank slumping continues to worsen but cobble at the toe appears stable. 2015: No observed changes. [2015 Site ID: SAC_143-5_R]
